WA-I- 521 Frame Farmhouse

Maryland Historical Trust
State Historic Sites Inventory Form

WA-I-521 Frame Farmhouse 10319 Sharpsburg Pike (MD 65) Funkstown Quadrangle

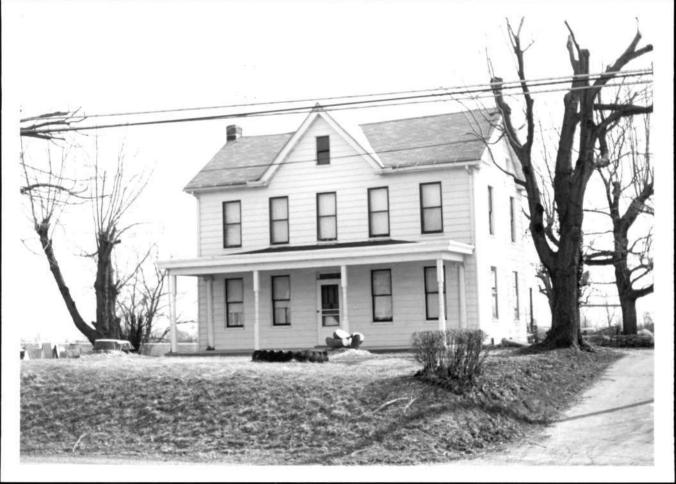
- 1. Frame Farmhouse WA-I-501 52/
- 2. Washington County, Maryland
- 3. Joe Getty
- 4. May 1983
- 5. Maryland Hist. Trust, Annapolis, Md.
- 6. West facade; camera facing east
- 7. 1/1
